Effects of Prior Aging at Elevated Temperature in Air and in Argon Environments on Creep Response of PMR-15 Neat Resin

**EFFECTS OF PRIOR AGING AT ELEVATED TEMPERATURE IN AIR AND IN
ARGON ENVIRONMENTS ON CREEP RESPONSE OF PMR-15 NEAT RESIN
AT 288°C**

THESIS

AFIT/GMS/ENY/07-M01

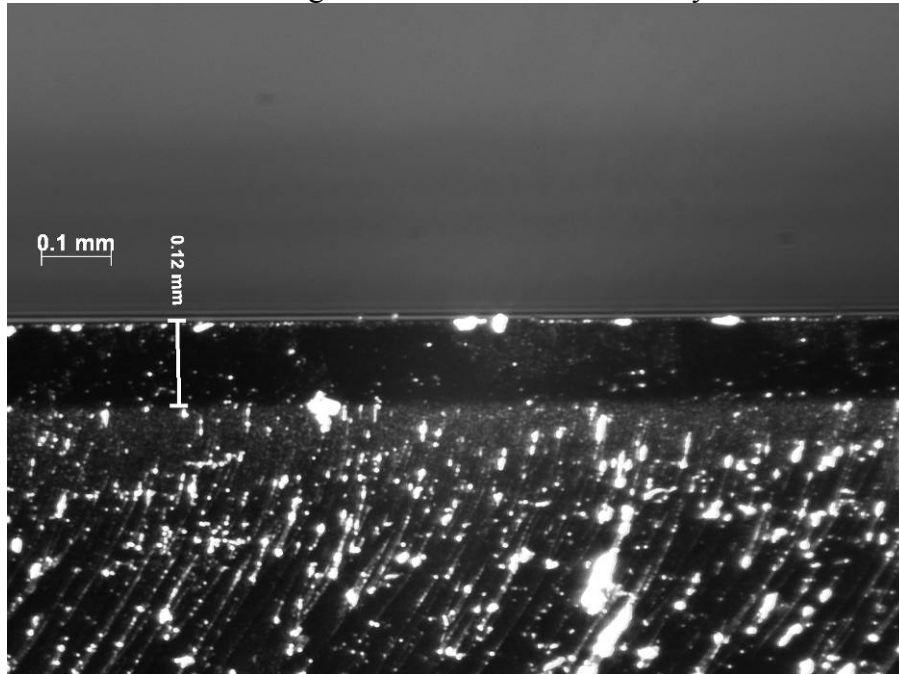
Figure 130 – Oxidation layer observed on fracture surface of sample aged in air at 288°C for 500 h. Showing formation of an oxidation layer 0.12 mm thick.
